## FACT SHEET – ~~INTERNAL ONLY~~

Environmental Stewardship Initiatives for  
PF225 Fence Construction along the Southwest Border  
U.S. Border Patrol Marfa Sector  
September 2010

U.S. Customs and  
Border Protection

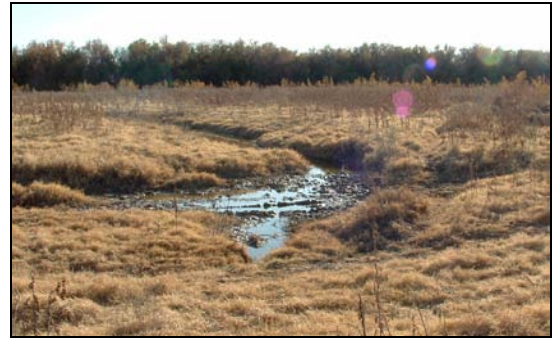
- No impacts on cultural resources occurred.
- Wetland areas were not impacted more than anticipated in the ESP. Section L-1 crossed-through portions of nine unavoidable wetlands and ephemeral washes totaling approximately 1 acre in size. Erosion and sediment control measures were implemented to minimize the impacts. A total of five wetland areas identified in the ESP at Sections (b) (7)(E) were completely avoided because construction did not occur at these sections.
- There were no adverse impacts on federally listed species or critical habitats of federally listed species.

**Wetland Area - Ephemeral Wash  
Section L-1**

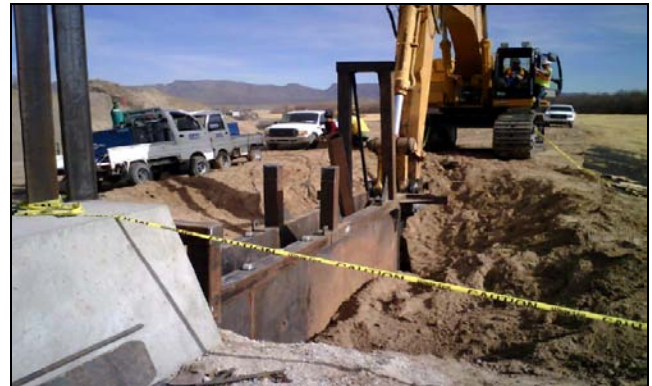
**Fence Construction  
Section L-1**

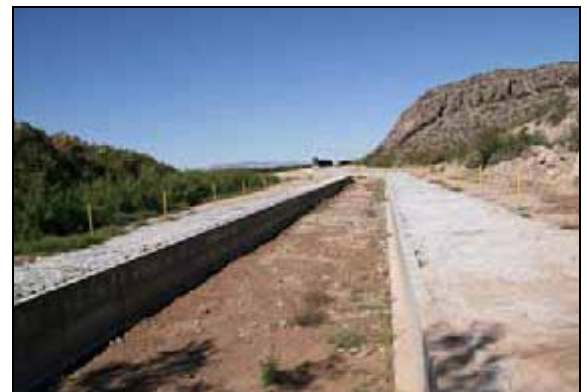
For Section (b) (7)(E) specifically, there was (b) (7)(E) and construction/maintenance road corridor compared to that anticipated in the ESP. There was, however, an approximately 34 percent increase in the acreage of disturbed soil compared to that anticipated in the ESP. This increase is primarily attributed to contractors requiring a wider fence and construction/maintenance road corridor and larger construction staging areas than what was originally anticipated prior to construction. Also contributing to the increased ground disturbance are the (b) (7)(E), which needed to be (b) (7)(E).

Concrete Trench at the Western End of Section L-1

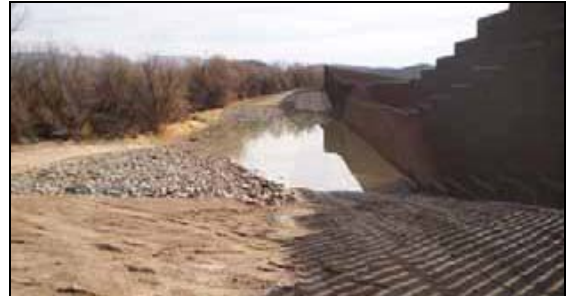
CBP's post-construction surveys identified one continuing issue that needs to be addressed in the future. Storm water that flows through the ephemeral washes that cross the fence and construction/maintenance road corridor occasionally backs up due to insufficient drainage and creates impassable water depths along the construction/maintenance roads. Improved drainage needs to be considered in the future to rectify this issue.

**High Water at an Ephemeral Wash  
Section L-1**
